Title: Case Study 2 - Hanford Am Exposure (1976)

Intended for: NEST NFFW 1110 course (Spring 2021 Semester)

Case Study 2 - Hanford Am Exposure (1976)

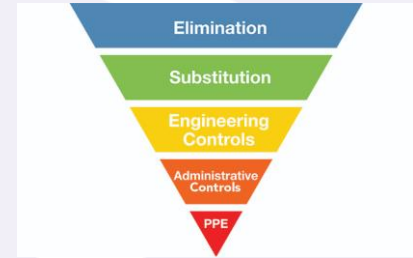
- Solvent extraction vs ion exchange
 - Continuous operation vs batch operation
- Resin design
 - Reillex HPQ specifically for high acid/high radiation environment
 - Glass column cage and pressure relief valve (PRV)
- Process operations
 - Maintain resin wet
 - Maintain resin in low acid
 - Limit time of radioactive material on the resin bed
 - Track the radiation exposure of the resin, replace on a cycle
 - Safe and stable configuration maintained
